# Access Compliance Report

## Public Rights-of-Way

### (Curb Ramps)

Main Street: SILVER\_FOX\_RD Cross Street: DRUID\_LN Location: NE

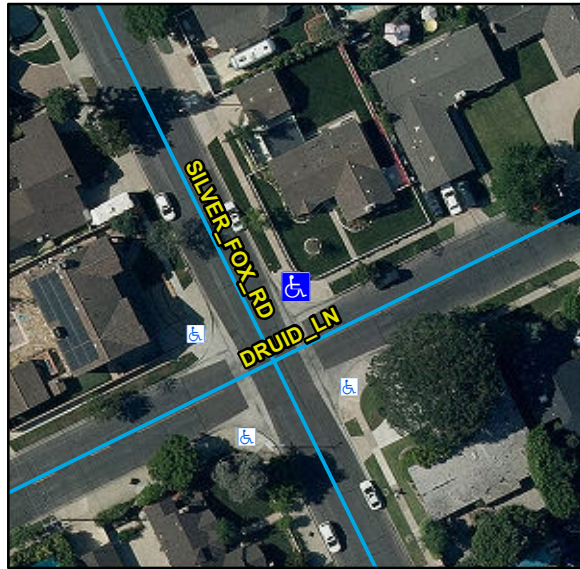
ADA ID: RPRK211206170945 Ramp Type: Type 1 - Perpendicular Diagonal Initial Pass/Fail: Fail Overall Compliance: No Severity Score: 2

| Compliance | Description | Data | Compliance | Description | Data |
|---|---|---|---|---|---|
| No | Ramp Cross Slope (%) | 2.8 | N/A | Flare Traversable LT | N/A |
| No | Gutter Lip Height (in) | 0.5 | | Road Run Slope (%) | 2.4 |

**Remove & Replace Curb Ramp With Two New Directional Ramps or Equivalent. Grind Gutter Lip.**

**R204.3, R304.5.3, R302.7.2, STD 1115**
