# Access Compliance Report Public Rights-of-Way (Curb Ramps)

Main Street: DRUID\_LN Cross Street: SILVER\_FOX\_RD Location: SE

ADA ID: RPRK211206171305 Ramp Type: Type 1 - Perpendicular Diagonal Initial Pass/Fail: Fail Overall Compliance: No Severity Score: 16

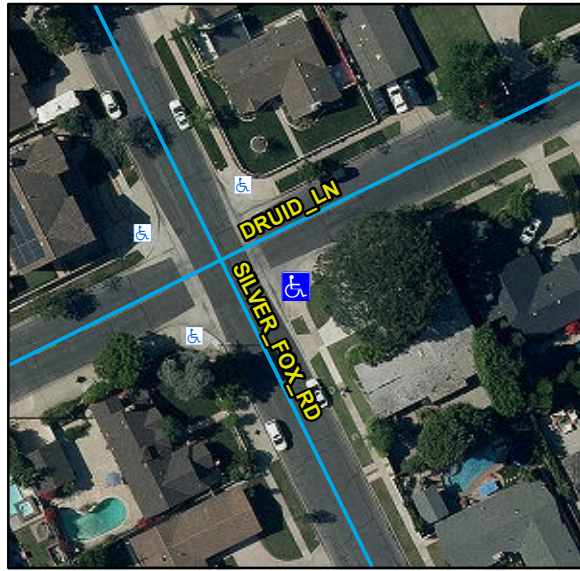
| Compliance | Description | Data | Compliance | Description | Data |
|---|---|---|---|---|---|
| No | Ramp Run Slope (%) | 9 | N/A | Flare Slope LT (%) | N/A |
| No | Ramp Cross Slope (%) | 2.1 | N/A | Flare Traversable LT | N/A |
| No | Gutter Lip Height (in) | 0.5 | | Road Run Slope (%) | 1.2 |

**Remove & Replace Curb Ramp With Two New Directional Ramps or Equivalent.**

**R304.2.2, R204.3, R304.5.3, R302.7.2, STD 1115**
