# Access Compliance Report Public Rights-of-Way (Curb Ramps)

Main Street: HILLROSE\_DR Cross Street: SILVER\_FOX\_RD Location: SE

ADA ID: RPRK211206172025 Ramp Type: Type 1 - Perpendicular Diagonal Initial Pass/Fail: Fail Overall Compliance: No Severity Score: 16

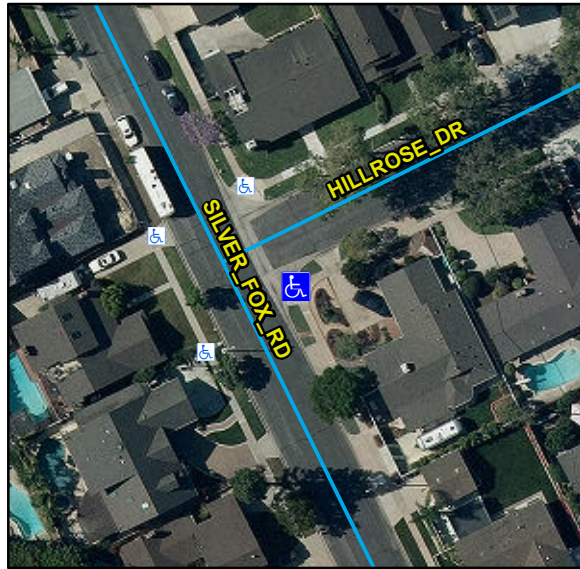
| Compliance | Description | Data | Compliance | Description | Data |
|---|---|---|---|---|---|
| No | Ramp Run Slope (%) | 9.4 | N/A | Flare Slope LT (%) | N/A |
| No | Ramp Cross Slope (%) | 3.7 | N/A | Flare Traversable LT | N/A |

Remove & Replace Curb Ramp With Two New Directional Ramps or Equivalent.

R204.3, R304.2.2, R304.5.3, STD 1115
