# Access Compliance Report Public Rights-of-Way (Curb Ramps)

Main Street: SILVER\_FOX\_RD Cross Street: HILLROSE\_DR Location: NE

ADA ID: RPRK211206172212 Ramp Type: Type 1 - Perpendicular Diagonal Initial Pass/Fail: Pass Overall Compliance: No Severity Score: 10

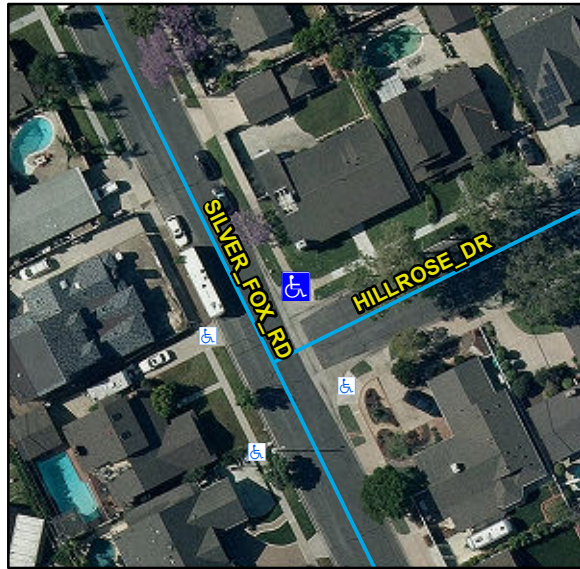
| Compliance | Description | Data | Compliance | Description | Data |
|---|---|---|---|---|---|
| Yes | Landing Cross Slope (%) | 1.4 | No | DWS Provided | No |
| No | Gutter Cross Slope (%) | 2.5 | | | |

Remove & Replace Curb Ramp With Two New Directional Ramps or Equivalent. Remove & Replace Gutter.

R204.3, R305, R304.5.3, STD 1115
