# Access Compliance Report Public Rights-of-Way (Curb Ramps)

| Main Street: SILVER_FOX_RD | | Cross Street: TIGERTAIL_DR | | Location: | SW |
| ADA ID: RPRK211206172601 | Ramp Type: Type 4 - Parallel | Initial Pass/Fail: Fail | Overall Compliance: No | Severity Score: | 15 |

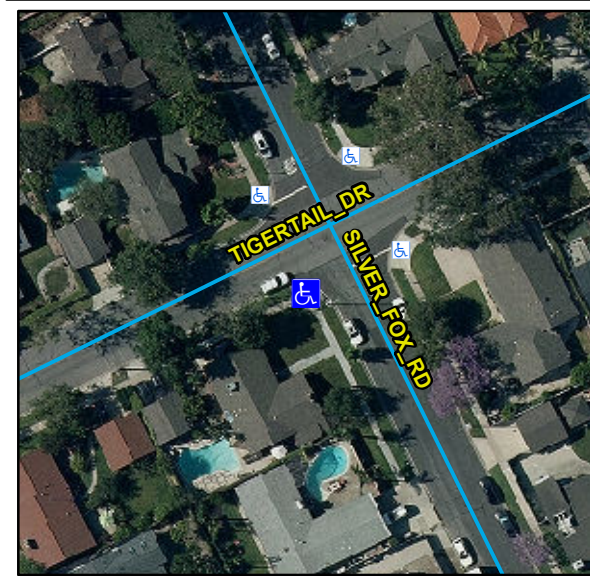
| Compliance | Description | Data | Compliance | Description | Data |
|---|---|---|---|---|---|
| No | Ramp Cross Slope LT (%) | 4.2 | No | Ramp Cross Slope RT (%) | 6.8 |

**Remove & Replace Curb Ramp With Two New Directional Ramps or Equivalent.**

**R204.3, R304.5.3, STD 1115**

Total Cost: \$ 4000

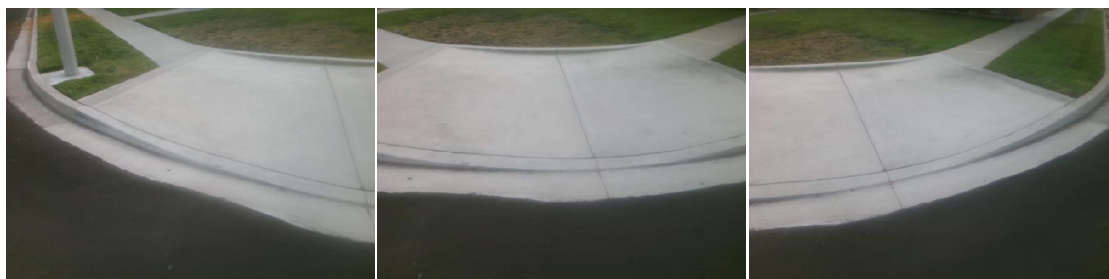
| Compliance | Description | Data | Compliance | Description | Data |
|---|---|---|---|---|---|
| N/A | Ramp Length LT (in) | 115 | N/A | Ramp Length RT (in) | 105 |
| Yes | Ramp Width LT (in) | 129 | Yes | Ramp Width RT (in) | 129 |
| Yes | Ramp Run Slope LT (%) | 3.6 | Yes | Ramp Run Slope RT (%) | 6.8 |
