# Access Compliance Report Public Rights-of-Way (Curb Ramps)

| Main Street: TIGERTAIL_DR | | Cross Street: SILVER_FOX_RD | | Location: | SE |
| ADA ID: RPRK211206172902 | Ramp Type: Type 4 - Parallel | Initial Pass/Fail: Fail | Overall Compliance: No | Severity Score: | 15 |

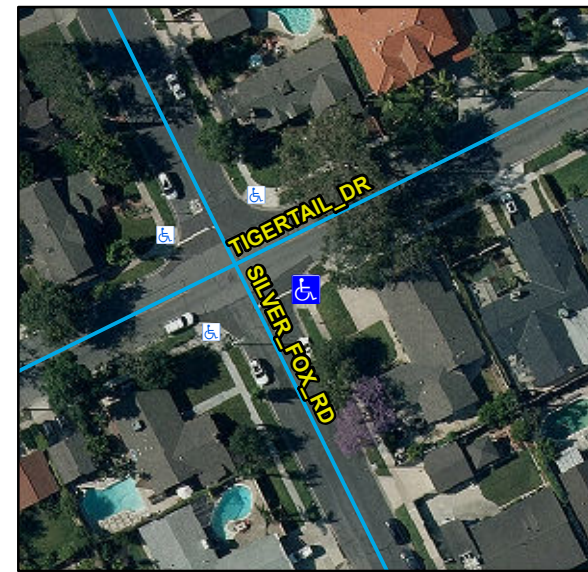
| Compliance | Description | Data | Compliance | Description | Data |
|---|---|---|---|---|---|
| No | Ramp Cross Slope LT (%) | 3.3 | No | Ramp Cross Slope RT (%) | 6.4 |

**Remove & Replace Curb Ramp With Two New Directional Ramps or Equivalent.**

**R204.3, R304.5.3, STD 1115**

Total Cost: \$ 4000

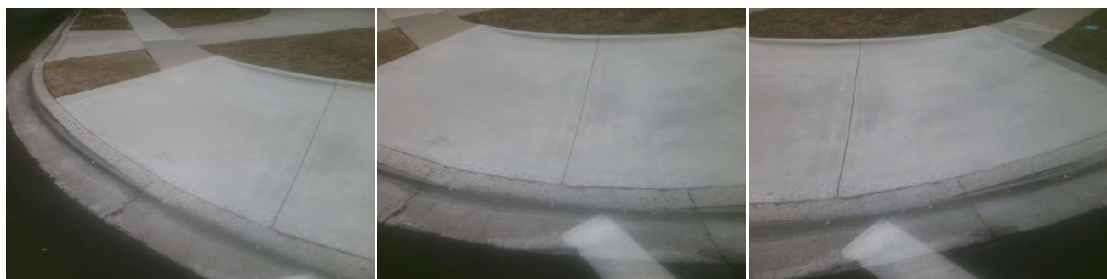
| Compliance | Description | Data | Compliance | Description | Data |
|---|---|---|---|---|---|
| N/A | Ramp Length LT (in) | 113 | N/A | Ramp Length RT (in) | 113 |
| Yes | Ramp Width LT (in) | 127 | Yes | Ramp Width RT (in) | 127 |
| Yes | Ramp Run Slope LT (%) | 3.2 | Yes | Ramp Run Slope RT (%) | 4.7 |
