# Access Compliance Report Public Rights-of-Way (Curb Ramps)

Main Street: SILVER\_FOX\_RD Cross Street: TIGERTAIL\_DR Location: NE

ADA ID: RPRK211206173147 Ramp Type: Type 4 - Parallel Initial Pass/Fail: Fail Overall Compliance: No Severity Score: 30

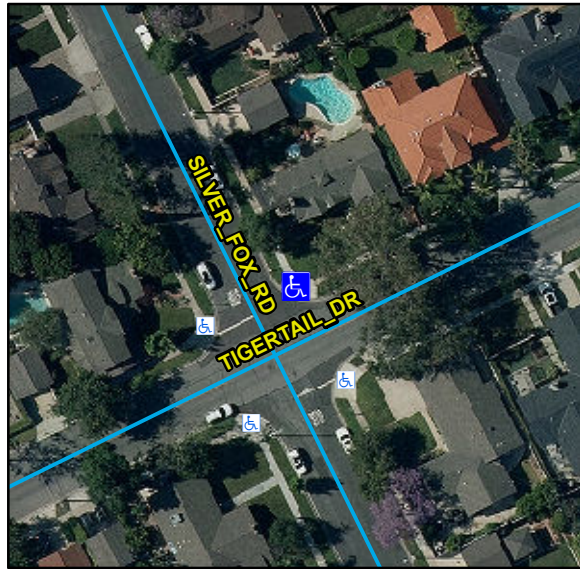
| Compliance | Description | Data | Compliance | Description | Data |
|---|---|---|---|---|---|
| N/A | Ramp Length LT (in) | 112 | N/A | Ramp Length RT (in) | 116 |
| Yes | Ramp Width LT (in) | 127 | Yes | Ramp Width RT (in) | 127 |
| Yes | Ramp Run Slope LT (%) | 2.3 | Yes | Ramp Run Slope RT (%) | 5.7 |
| No | Ramp Cross Slope LT (%) | 3.3 | No | Ramp Cross Slope RT (%) | 8 |

**Remove & Replace Curb Ramp With Two New Directional Ramps or Equivalent.**

**R204.3, R304.5.3, STD 1115**

Total Cost: \$ 4000
