# Access Compliance Report Public Rights-of-Way (Curb Ramps)

Main Street: TIGERTAIL\_DR Cross Street: SILVER\_FOX\_RD Location: NW

ADA ID: RPRK211206173430 Ramp Type: Type 4 - Parallel Initial Pass/Fail: Fail Overall Compliance: No Severity Score: 2

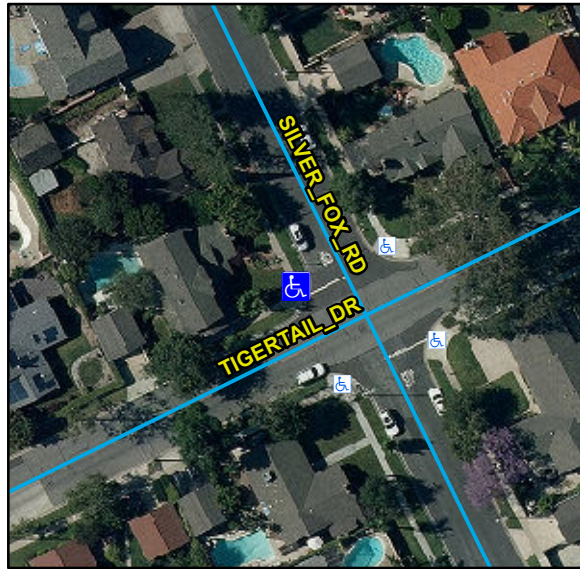
| Compliance | Description | Data | Compliance | Description | Data |
|---|---|---|---|---|---|
| No | Ramp Cross Slope LT (%) | 3.5 | No | Ramp Cross Slope RT (%) | 2.5 |

**Remove & Replace Curb Ramp With Two New Directional Ramps or Equivalent.**

**R304.5.3, STD 1115**

Total Cost: \$ 4000
