# Access Compliance Report Public Rights-of-Way (Curb Ramps)

Main Street: BRIMHALL\_DR Cross Street: SILVER\_FOX\_RD Location: SE

ADA ID: RPRK211206173802 Ramp Type: Type 1 - Perpendicular Diagonal Initial Pass/Fail: Pass Overall Compliance: No Severity Score: 10

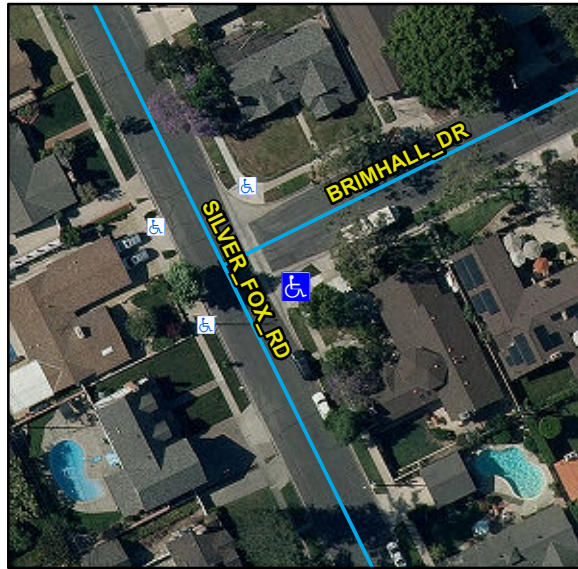
| Compliance | Description | Data | Compliance | Description | Data |
|---|---|---|---|---|---|
| Yes | Landing Cross Slope (%) | 1.9 | No | DWS Provided | No |

Remove & Replace Curb Ramp With Two New Directional Ramps or Equivalent.
