# Access Compliance Report Public Rights-of-Way (Curb Ramps)

Main Street: SILVER\_FOX\_RD Cross Street: BRIMHALL\_DR Location: NE

ADA ID: RPRK211206174108 Ramp Type: Type 1 - Perpendicular Diagonal Initial Pass/Fail: Pass Overall Compliance: No Severity Score: 12

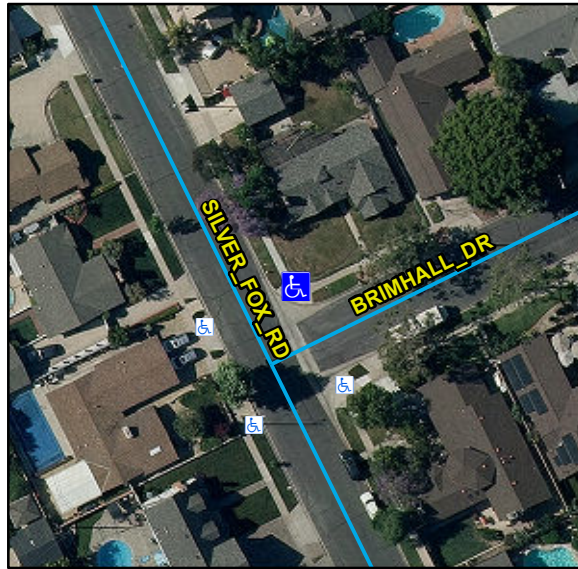
| Compliance | Description | Data | Compliance | Description | Data |
|---|---|---|---|---|---|
| Yes | Landing Cross Slope (%) | 2 | No | DWS Provided | No |
| No | Gutter Cross Slope (%) | 3.9 | | | |

Remove & Replace Curb Ramp With Two New Directional Ramps or Equivalent. Remove & Replace Gutter.
