# Access Compliance Report Public Rights-of-Way (Curb Ramps)

Main Street: WALKER\_LEE\_DR Cross Street: SILVER\_FOX\_RD Location: SE

ADA ID: RPRK211206174617 Ramp Type: Type 1 - Perpendicular Diagonal Initial Pass/Fail: Fail Overall Compliance: No Severity Score: 2

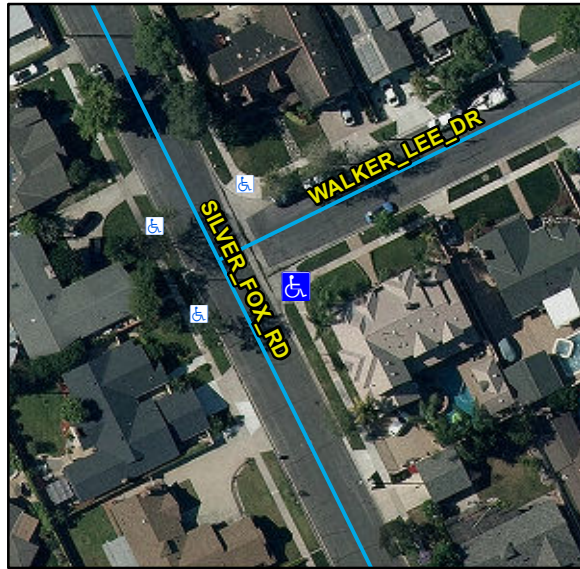
R204.3, R304.5.3, STD 1115

| Compliance | Description | Data | Compliance | Description | Data |
|---|---|---|---|---|---|
| No | Ramp Cross Slope (%) | 2.3 | N/A | Flare Traversable LT | N/A |

Remove & Replace Curb Ramp With Two New Directional Ramps or Equivalent.
