# Access Compliance Report Public Rights-of-Way (Curb Ramps)

Main Street: SILVER\_FOX\_RD Cross Street: WALKER\_LEE\_DR Location: NE

ADA ID: RPRK211206174746 Ramp Type: Type 1 - Perpendicular Diagonal Initial Pass/Fail: Pass Overall Compliance: No Severity Score: 10

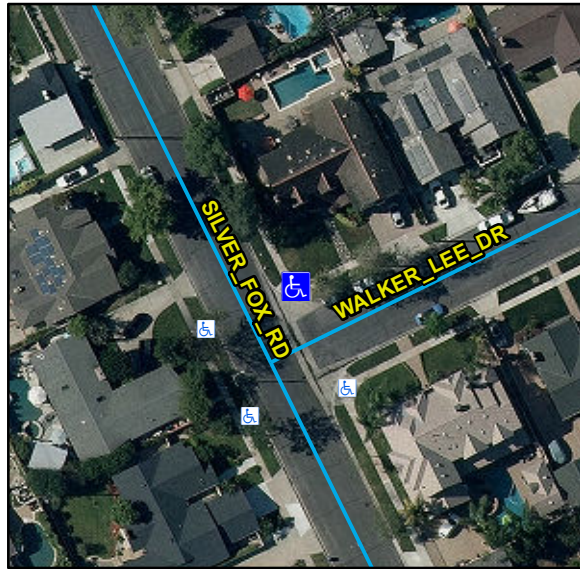
| Compliance | Description | Data | Compliance | Description | Data |
|---|---|---|---|---|---|
| Yes | Landing Cross Slope (%) | 0.1 | No | DWS Provided | No |
| No | Gutter Cross Slope (%) | 3.2 | | | |

Remove & Replace Curb Ramp With Two New Directional Ramps or Equivalent. Remove & Replace Gutter.

R204.3, R305, R304.5.3, STD 1115
