# Access Compliance Report Public Rights-of-Way (Curb Ramps)

Main Street: COPA\_DE\_ORO\_DR Cross Street: SILVER\_FOX\_RD Location: SE

ADA ID: RPRK211206175603 Ramp Type: Type 1 - Perpendicular Diagonal Initial Pass/Fail: Fail Overall Compliance: No Severity Score: 2

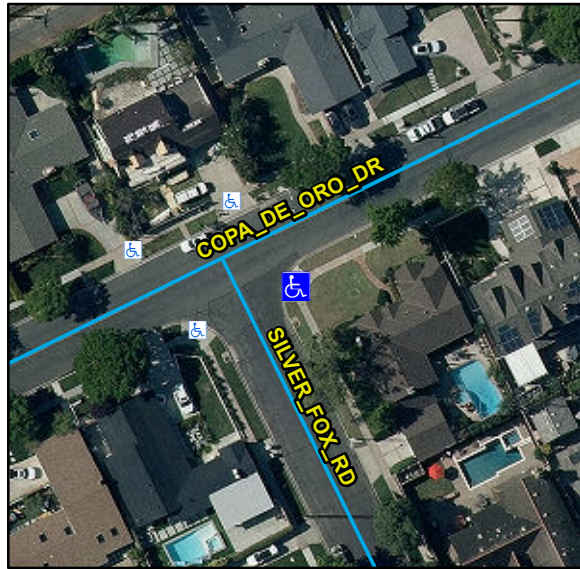
| Compliance | Description | Data | Compliance | Description | Data |
|---|---|---|---|---|---|
| No | Ramp Cross Slope (%) | 3.5 | N/A | Flare Traversable LT | N/A |

Remove & Replace Curb Ramp With Two New Directional Ramps or Equivalent.
