# Access Compliance Report Public Rights-of-Way (Curb Ramps)

Main Street: COPA\_DE\_ORO\_DR Cross Street: MONTECITO\_RD Location: NW

ADA ID: RPRK211206180251 Ramp Type: Type 4 - Parallel Initial Pass/Fail: Fail Overall Compliance: No Severity Score: 15

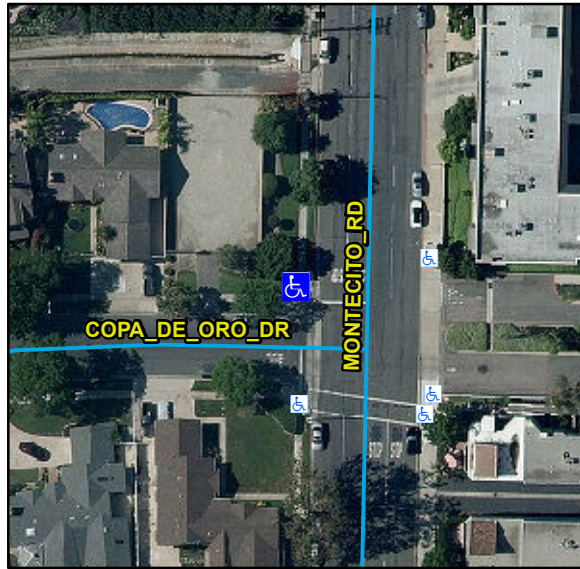
| Compliance | Description | Data | Compliance | Description | Data |
|---|---|---|---|---|---|
| No | Ramp Cross Slope LT (%) | 2.1 | No | Ramp Cross Slope RT (%) | 6.8 |

**Remove & Replace Curb Ramp With Two New Directional Ramps or Equivalent.**

**R304.5.3, STD 1115**

Total Cost: \$ 4000
