# Access Compliance Report Public Rights-of-Way (Curb Ramps)

Main Street: MONTECITO\_RD Cross Street: COPA\_DE\_ORO\_DR Location: SW

ADA ID: RPRK211206180554 Ramp Type: Type 4 - Parallel Initial Pass/Fail: Fail Overall Compliance: No Severity Score: 30

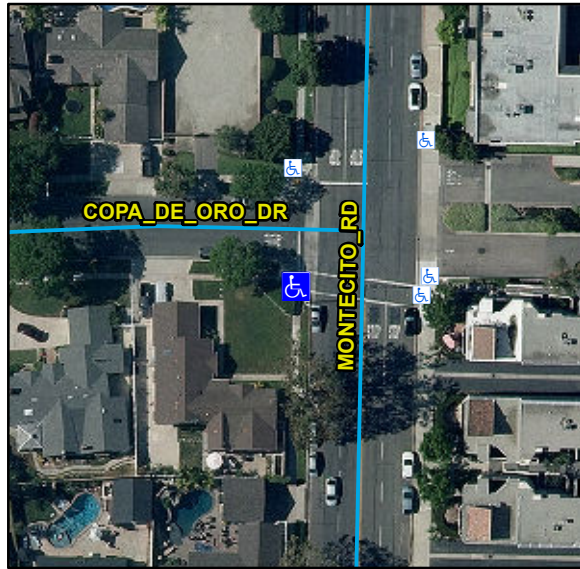
| Compliance | Description | Data | Compliance | Description | Data |
|---|---|---|---|---|---|
| No | Ramp Cross Slope LT (%) | 4.2 | No | Ramp Cross Slope RT (%) | 7.2 |

**Remove & Replace Curb Ramp With Two New Directional Ramps or Equivalent.**

**R204.3, R304.5.3, STD 1115**

Total Cost: \$ 4000
