# Access Compliance Report Public Rights-of-Way (Curb Ramps)

| Main Street: MONTECITO_RD | | Cross Street: WALKER_LEE_DR | | Location: | SW |
| ADA ID: RPRK211206181234 | Ramp Type: Type 4 - Parallel | Initial Pass/Fail: Fail | Overall Compliance: No | Severity Score: | 2 |

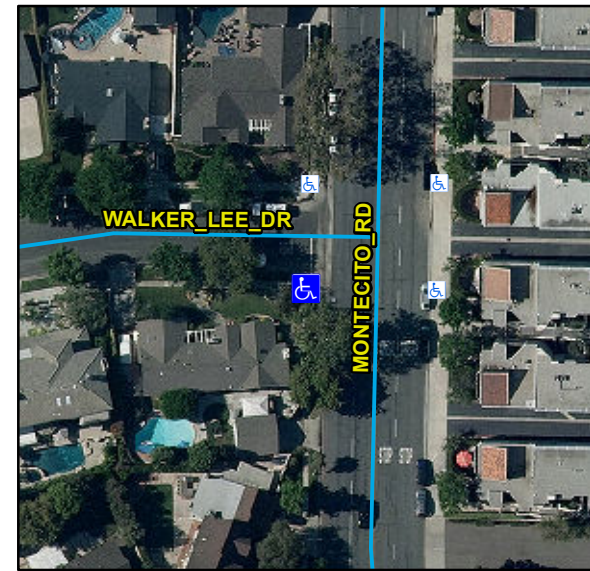
| Compliance | Description | Data | Compliance | Description | Data |
|---|---|---|---|---|---|
| No | Ramp Cross Slope LT (%) | 3 | Yes | Ramp Cross Slope RT (%) | 1.5 |

**Remove & Replace Curb Ramp With Two New Directional Ramps or Equivalent.**

**R204.3, R304.5.3, STD 1115**

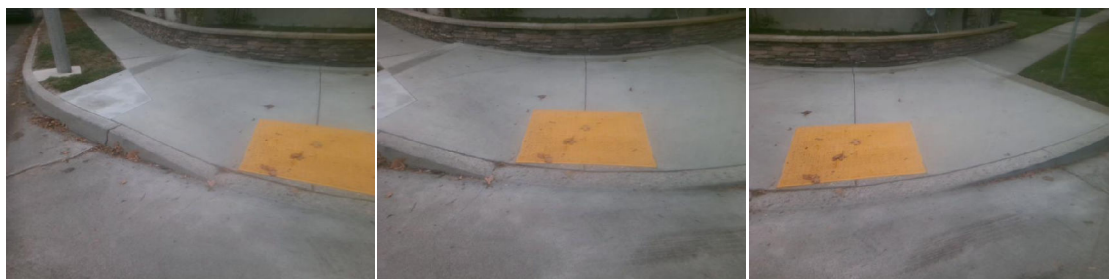
| Compliance | Description | Data | Compliance | Description | Data |
| N/A | Ramp Length LT (in) | 112 | N/A | Ramp Length RT (in) | 115 |
| Yes | Ramp Width LT (in) | 110 | Yes | Ramp Width RT (in) | 110 |
| Yes | Ramp Run Slope LT (%) | 6.4 | Yes | Ramp Run Slope RT (%) | 1.6 |
