# Access Compliance Report Public Rights-of-Way (Curb Ramps)

Main Street: WALKER\_LEE\_DR Cross Street: MONTECITO\_RD Location: NW

ADA ID: RPRK211206181541 Ramp Type: Type 4 - Parallel Initial Pass/Fail: Fail Overall Compliance: No Severity Score: 30

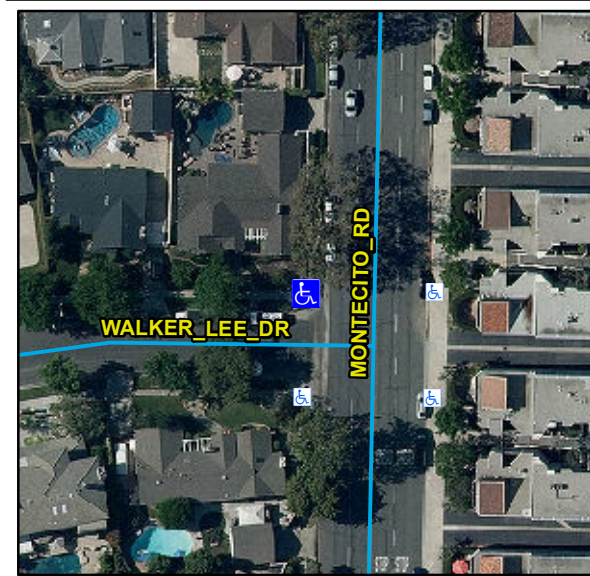
| Compliance | Description | Data | Compliance | Description | Data |
|---|---|---|---|---|---|
| Yes | Ramp Cross Slope LT (%) | 1.4 | No | Ramp Cross Slope RT (%) | 7.3 |

Possible Solutions:  
**Remove & Replace Curb Ramp With Two New Directional Ramps or Equivalent.**

OC Std/PROW:  
**R204.3, R304.5.3, STD 1115**
