# Access Compliance Report Public Rights-of-Way (Curb Ramps)

Main Street: DRUID\_LN Cross Street: OAK\_WAY\_DR Location: SE

ADA ID: RPRK211207111325 Ramp Type: Type 1 - Perpendicular Diagonal Initial Pass/Fail: Pass Overall Compliance: No Severity Score: 12

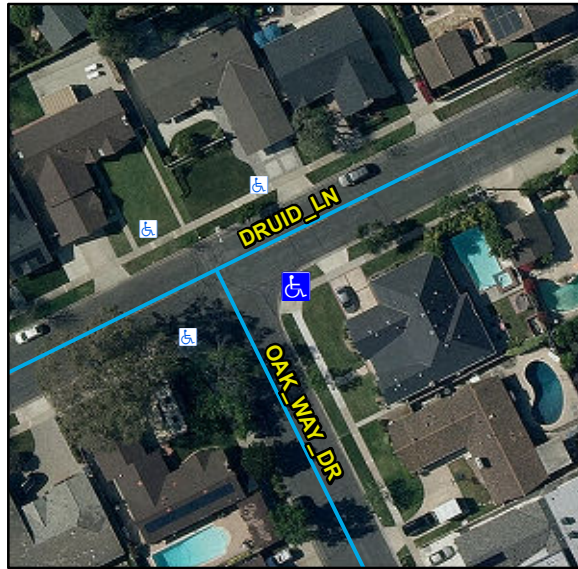
| Compliance | Description | Data | Compliance | Description | Data |
|---|---|---|---|---|---|
| No | Ramp Cross Slope (%) | 2.7 | N/A | Flare Traversable LT | No |
| Yes | Landing Cross Slope (%) | 1.4 | No | DWS Provided | No |
| No | Gutter Cross Slope (%) | 2.6 | | | |

Remove & Replace Curb Ramp With Two New Directional Ramps or Equivalent. Remove & Replace Gutter.

R204.3, R304.5.3, R305, STD 1115
