# Access Compliance Report Public Rights-of-Way (Curb Ramps)

| Main Street: OAK_WAY_DR | | Cross Street: DRUID_LN | | Location: | SW |
| ADA ID: RPRK211207111631 | Ramp Type:Type 1 - Perpendicular Diagonal Initial Pass/Fail: Fail | | Overall Compliance: No | Severity Score: | 2 |

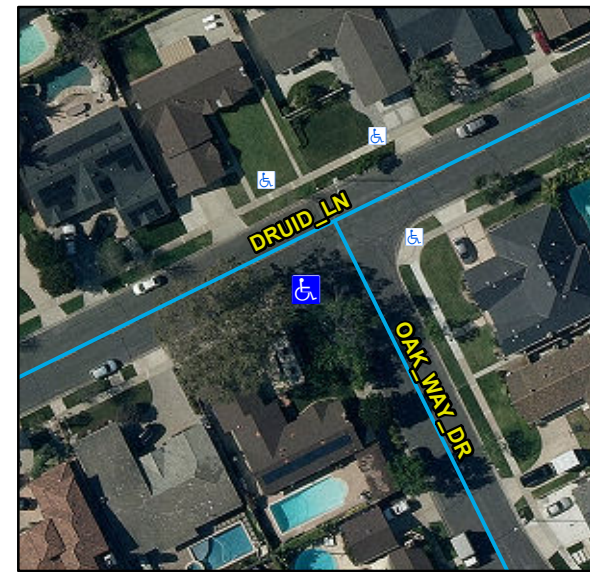
| Compliance | Description | Data | Compliance | Description | Data |
|---|---|---|---|---|---|
| No | Ramp Cross Slope (%) | 2.6 | N/A | Flare Traversable LT | N/A |

**Remove & Replace Curb Ramp With Two New Directional Ramps or Equivalent.**

**R304.2.2, R204.3, R304.5.3, STD 1115**
