# Access Compliance Report Public Rights-of-Way (Curb Ramps)

Main Street: DRUID\_LN Cross Street: ROWENA\_DR Location: SE

ADA ID: RPRK211207112224 Ramp Type: Type 1 - Perpendicular Diagonal Initial Pass/Fail: Fail Overall Compliance: No Severity Score: 2

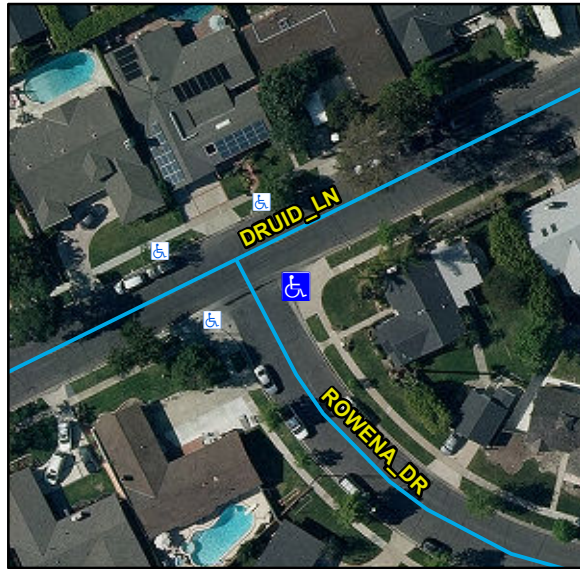
| Compliance | Description | Data | Compliance | Description | Data |
|---|---|---|---|---|---|
| No | Ramp Cross Slope (%) | 3.4 | N/A | Flare Traversable LT | N/A |
| No | Gutter Lip Height (in) | 0.5 | | Road Run Slope (%) | 2 |

Remove & Replace Curb Ramp With Two New Directional Ramps or Equivalent. Grind Gutter Lip.
