# Access Compliance Report Public Rights-of-Way (Curb Ramps)

Main Street: ROWENA\_DR Cross Street: DRUID\_LN Location: SW

ADA ID: RPRK211207112506 Ramp Type: Type 1 - Perpendicular Diagonal Initial Pass/Fail: Fail Overall Compliance: No Severity Score: 2

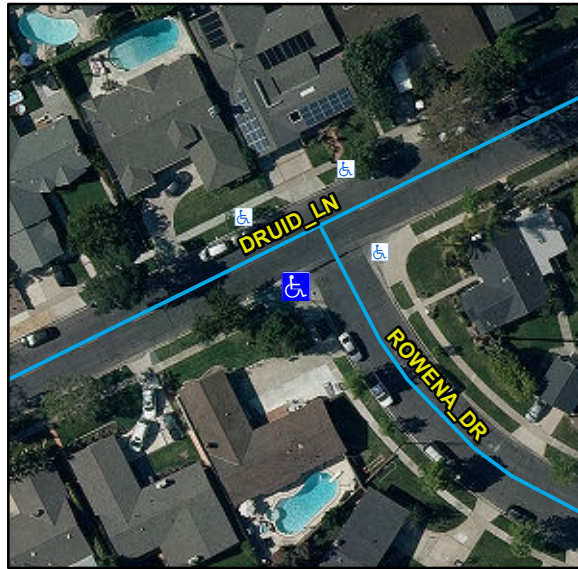
| Compliance | Description | Data | Compliance | Description | Data |
|---|---|---|---|---|---|
| No | Ramp Cross Slope (%) | 3.9 | N/A | Flare Traversable LT | N/A |
| N/A | Gutter Ponding | N/A | No | Curb Slope | 5.1 |

Remove & Replace Curb Ramp With Two New Directional Ramps or Equivalent.

R304.2.2, R204.3, R304.5.3, STD 1115
