# Access Compliance Report Public Rights-of-Way (Curb Ramps)

Main Street: FOSTER\_RD Cross Street: DRUID\_LN Location: N

ADA ID: RPRK211207112824 Ramp Type: Type 4 - Parallel Initial Pass/Fail: Fail Overall Compliance: No Severity Score: 2

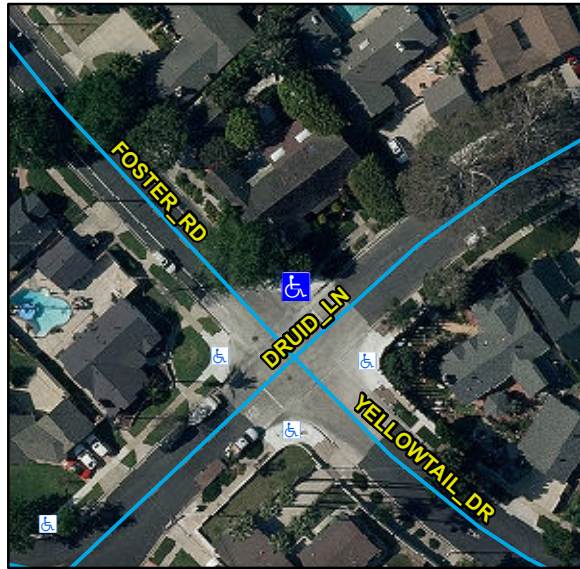
| Compliance | Description | Data | Compliance | Description | Data |
|---|---|---|---|---|---|
| No | Ramp Cross Slope LT (%) | 3.3 | No | Ramp Cross Slope RT (%) | 5 |

**Remove & Replace Curb Ramp With Two New Directional Ramps or Equivalent.**

R304.5.3, STD 1115
