# Access Compliance Report Public Rights-of-Way (Curb Ramps)

| Main Street: DRUID_LN | | Cross Street: FOSTER_RD | | Location: | W |
| ADA ID: RPRK211207113156 | Ramp Type: Type 4 - Parallel | Initial Pass/Fail: Fail | Overall Compliance: No | Severity Score: | 15 |

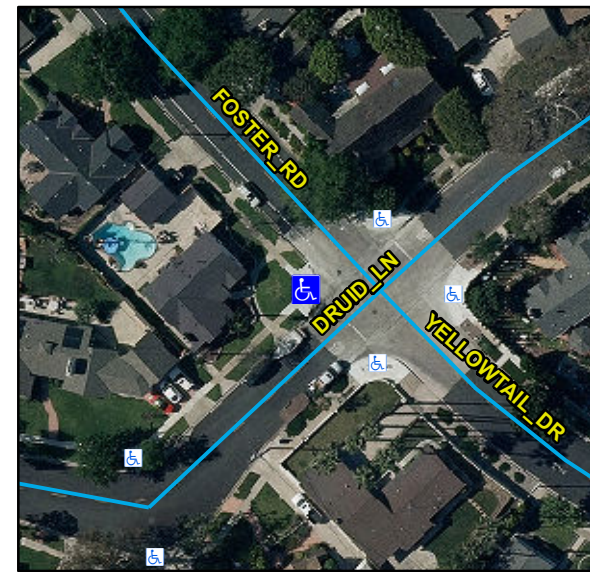
| Compliance | Description | Data | Compliance | Description | Data |
|---|---|---|---|---|---|
| Yes | Ramp Cross Slope LT (%) | 0.1 | No | Ramp Cross Slope RT (%) | 5.6 |

**Remove & Replace Curb Ramp With Two New Directional Ramps or Equivalent.**

**R304.5.3, STD 1115**

Total Cost: \$ 4000
