# Access Compliance Report Public Rights-of-Way (Curb Ramps)

Main Street: YELLOWTAIL\_DR Cross Street: DRUID\_LN Location: SW

ADA ID: RPRK211207113429 Ramp Type: Type 4 - Parallel Initial Pass/Fail: Fail Overall Compliance: No Severity Score: 15

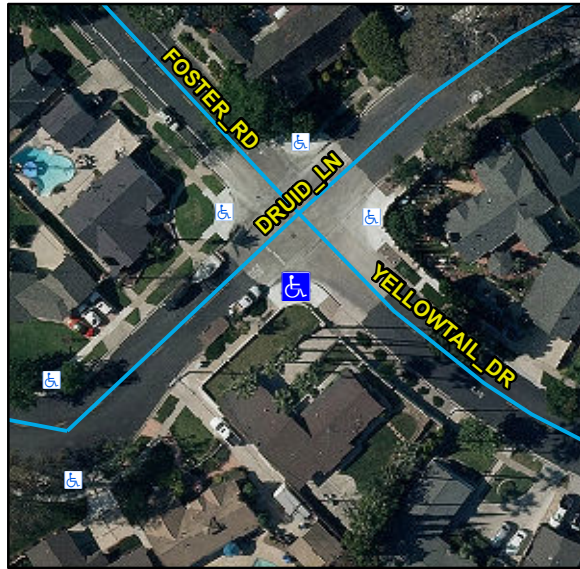
| Compliance | Description | Data | Compliance | Description | Data |
|---|---|---|---|---|---|
| N/A | Ramp Length LT (in) | 98 | N/A | Ramp Length RT (in) | 88 |
| Yes | Ramp Width LT (in) | 74 | Yes | Ramp Width RT (in) | 74 |
| Yes | Ramp Run Slope LT (%) | 2.6 | Yes | Ramp Run Slope RT (%) | 6.7 |
| No | Ramp Cross Slope LT (%) | 2.9 | No | Ramp Cross Slope RT (%) | 6.9 |

**Remove & Replace Curb Ramp With Two New Directional Ramps or Equivalent.**

**R304.5.3, STD 1115**
