# Access Compliance Report Public Rights-of-Way (Curb Ramps)

Main Street: DRUID\_LN Cross Street: YELLOWTAIL\_DR Location: SE

ADA ID: RPRK211207113718 Ramp Type: Type 4 - Parallel Initial Pass/Fail: Fail Overall Compliance: No Severity Score: 15

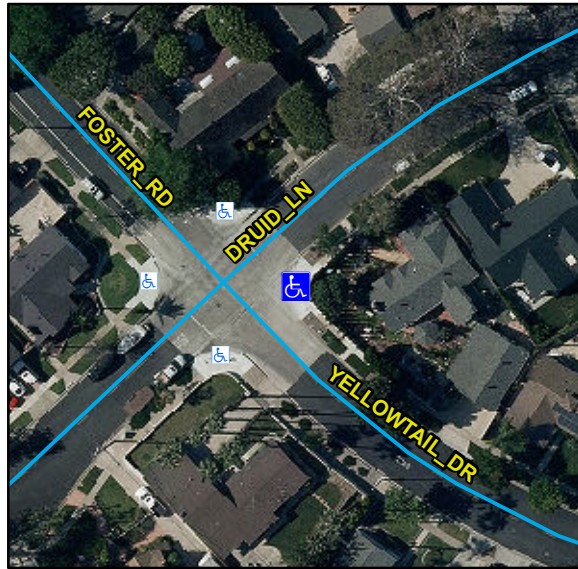
| Compliance | Description | Data | Compliance | Description | Data |
|---|---|---|---|---|---|
| Yes | Ramp Cross Slope LT (%) | 2 | No | Ramp Cross Slope RT (%) | 5.4 |

**Remove & Replace Curb Ramp With Two New Directional Ramps or Equivalent.**

**R304.5.3, STD 1115**
