# Access Compliance Report Public Rights-of-Way (Curb Ramps)

Main Street: SPUR\_LN Cross Street: MARTHA\_ANN\_DR Location: E

ADA ID: RPRK211207114350 Ramp Type: Type 1 - Perpendicular Diagonal Initial Pass/Fail: Fail Overall Compliance: No Severity Score: 2

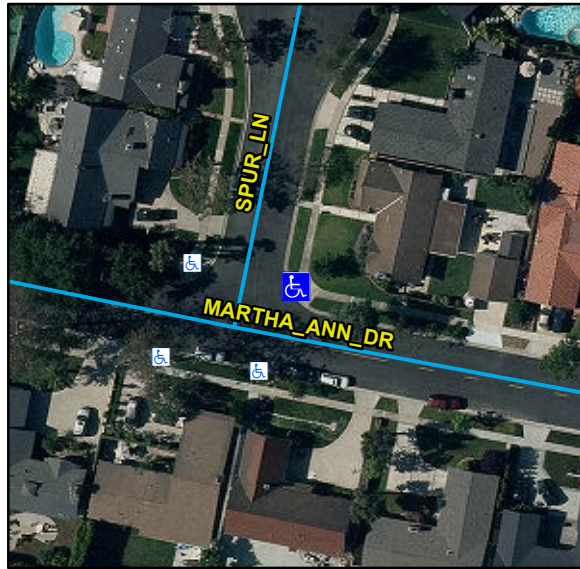
| Compliance | Description | Data | Compliance | Description | Data |
|---|---|---|---|---|---|
| No | Ramp Cross Slope (%) | 3.1 | N/A | Flare Traversable LT | N/A |

Remove & Replace Curb Ramp With Two New Directional Ramps or Equivalent.

R304.2.2, R204.3, R304.5.3, STD 1115
