# Access Compliance Report Public Rights-of-Way (Curb Ramps)

Main Street: MARTHA\_ANN\_DR Cross Street: SPUR\_LN Location: N

ADA ID: RPRK211207114544 Ramp Type: Type 1 - Perpendicular Diagonal Initial Pass/Fail: Pass Overall Compliance: No Severity Score: 2

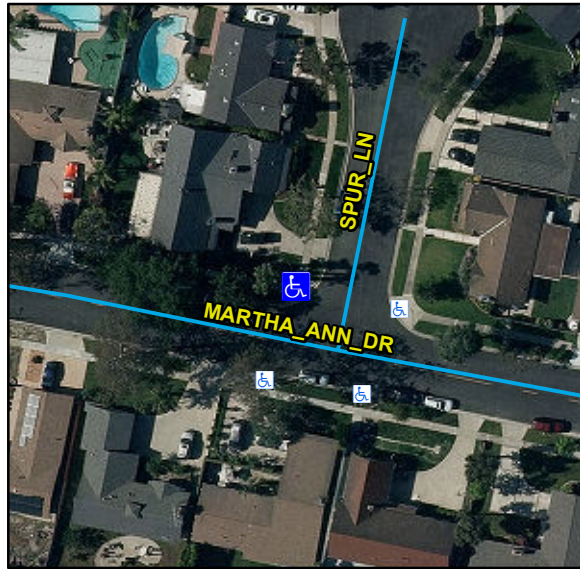
Gutter Ponding Observed.

| Compliance | Description | Data | Compliance | Description | Data |
|---|---|---|---|---|---|
| No | Gutter Ponding | Yes | Yes | Curb Slope | 1 |

Possible Solutions:

R302.7, STD 1115

Total Cost: \$ 252
