# Access Compliance Report Public Rights-of-Way (Curb Ramps)

Main Street: MARTHA\_ANN\_DR Cross Street: KEITHLEY\_DR Location: NW

ADA ID: RPRK211207115349 Ramp Type: Type 1 - Perpendicular Diagonal Initial Pass/Fail: Fail Overall Compliance: No Severity Score: 2

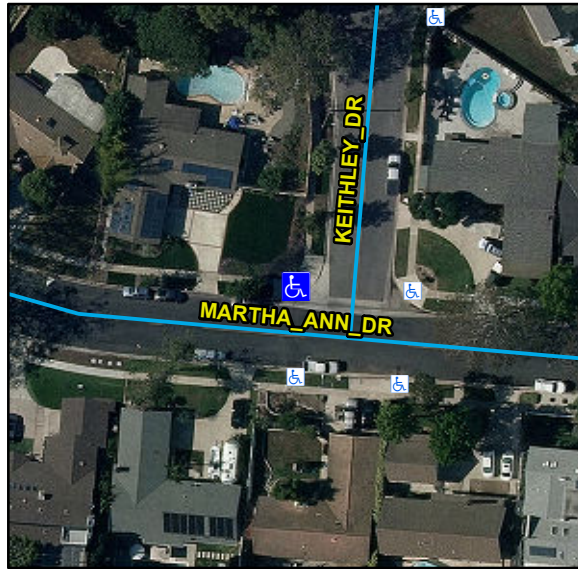
| Compliance | Description | Data | Compliance | Description | Data |
|---|---|---|---|---|---|
| No | Ramp Cross Slope (%) | 3.4 | N/A | Flare Traversable LT | N/A |

Remove & Replace Curb Ramp With Two New Directional Ramps or Equivalent.

R304.5.3, STD 1115
