# Access Compliance Report Public Rights-of-Way (Curb Ramps)

Main Street: BRIMHALL\_DR Cross Street: MARTHA\_ANN\_DR Location: SE

ADA ID: RPRK211207115945 Ramp Type: Type 1 - Perpendicular Diagonal Initial Pass/Fail: Pass Overall Compliance: No Severity Score: 17

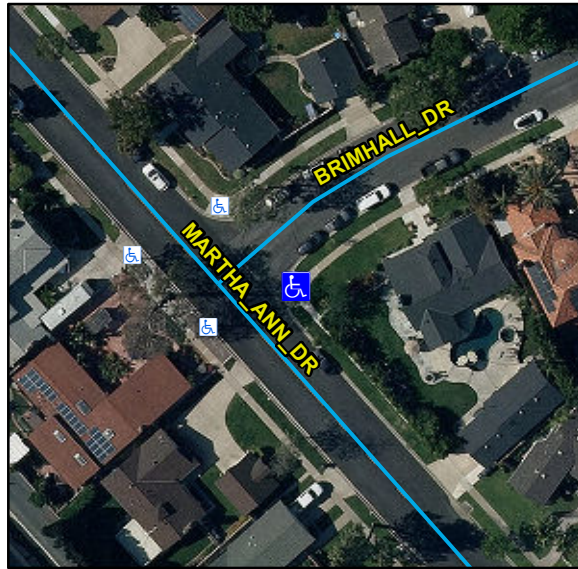
| Compliance | Description | Data | Compliance | Description | Data |
|---|---|---|---|---|---|
| No | Ramp Cross Slope (%) | 2.3 | N/A | Flare Traversable LT | No |
| No | Landing Cross Slope (%) | 4 | No | DWS Provided | No |
| No | Gutter Run Slope (%) | 8.5 | | Road Cross Slope (%) | 6.4 |

Remove & Replace Curb Ramp With Two New Directional Ramps or Equivalent. Remove & Replace Gutter.
