# Access Compliance Report Public Rights-of-Way (Curb Ramps)

Main Street: MARTHA\_ANN\_DR Cross Street: BRIMHALL\_DR Location: NE

ADA ID: RPRK211207120252 Ramp Type: Type 1 - Perpendicular Diagonal Initial Pass/Fail: Pass Overall Compliance: No Severity Score: 16

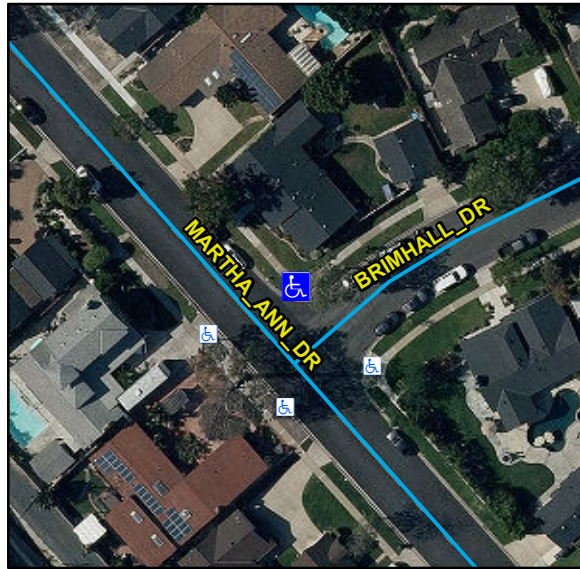
| Compliance | Description | Data | Compliance | Description | Data |
|---|---|---|---|---|---|
| No | Ramp Cross Slope (%) | 3.1 | N/A | Flare Traversable LT | No |
| No | Landing Cross Slope (%) | 2.6 | No | DWS Provided | No |
| No | Gutter Ponding | Yes | N/A | Curb Slope | 6.2 |
| No | Gutter Run Slope (%) | 6.2 | | Road Cross Slope (%) | 9.5 |
| No | Gutter Cross Slope (%) | 2.8 | | | |

Remove & Replace Curb Ramp With Two New Directional Ramps or Equivalent. Remove & Replace Gutter.
