# Access Compliance Report Public Rights-of-Way (Curb Ramps)

| Main Street: COPA_DE_ORO_DR | | Cross Street: MARTHA_ANN_DR | | Location: | SE |
| ADA ID: RPRK211207121427 | Ramp Type: Type 4 - Parallel | Initial Pass/Fail: Fail | Overall Compliance: No | Severity Score: | 15 |

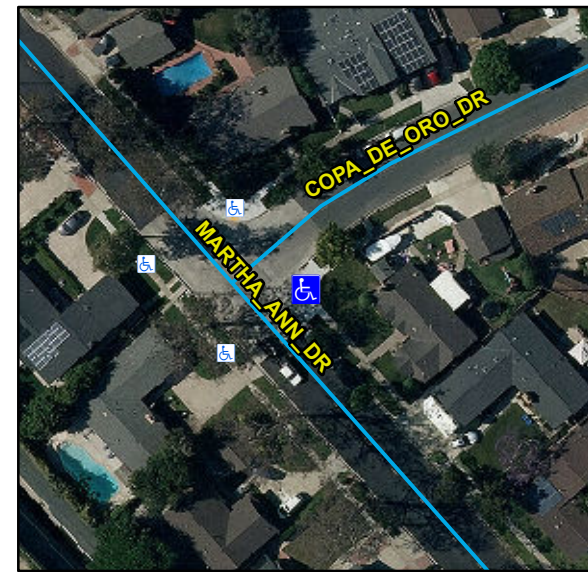
| Compliance | Description | Data | Compliance | Description | Data |
|---|---|---|---|---|---|
| No | Ramp Cross Slope LT (%) | 2.5 | No | Ramp Cross Slope RT (%) | 6.7 |

**Remove & Replace Curb Ramp With Two New Directional Ramps or Equivalent.**

**R304.5.3, STD 1115**

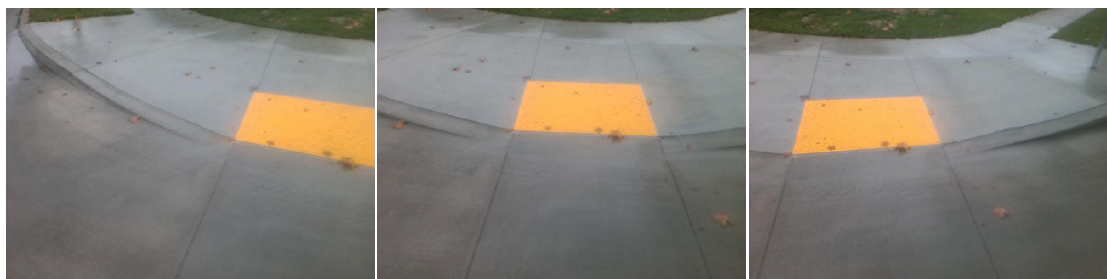
| Compliance | Description | Data | Compliance | Description | Data |
|---|---|---|---|---|---|
| N/A | Ramp Length LT (in) | 78 | N/A | Ramp Length RT (in) | 79 |
| Yes | Ramp Width LT (in) | 86 | Yes | Ramp Width RT (in) | 86 |
| Yes | Ramp Run Slope LT (%) | 4.2 | Yes | Ramp Run Slope RT (%) | 0.8 |
