# Access Compliance Report Public Rights-of-Way (Curb Ramps)

| Main Street: MARTHA_ANN_DR | | Cross Street: COPA_DE_ORO_DR | | Location: | NE |
| ADA ID: RPRK211207121720 | Ramp Type: Type 4 - Parallel | Initial Pass/Fail: Fail | Overall Compliance: No | Severity Score: | 15 |

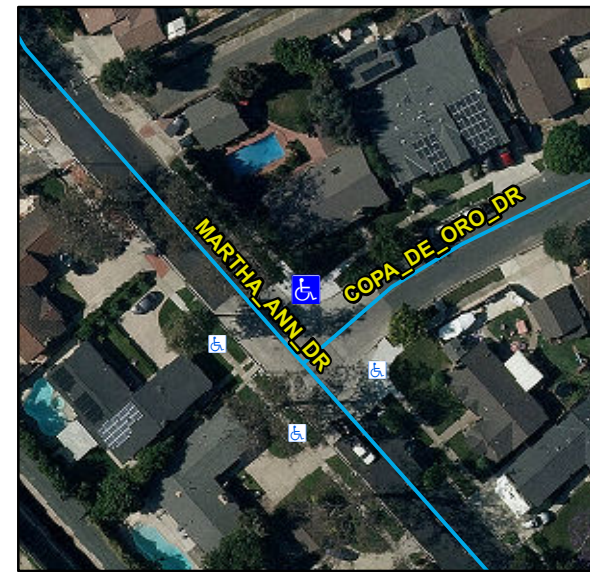
| Compliance | Description | Data | Compliance | Description | Data |
|---|---|---|---|---|---|
| No | Ramp Cross Slope LT (%) | 2.3 | No | Ramp Cross Slope RT (%) | 6.7 |

**Remove & Replace Curb Ramp With Two New Directional Ramps or Equivalent.**

**R304.5.3, STD 1115**

Total Cost: \$ 4000
