# Access Compliance Report Public Rights-of-Way (Curb Ramps)

Main Street: FOSTER\_RD Cross Street: COPA\_DE\_ORO\_DR Location: SW

ADA ID: RPRK211207122445 Ramp Type: Type 4 - Parallel Initial Pass/Fail: Fail Overall Compliance: No Severity Score: 30

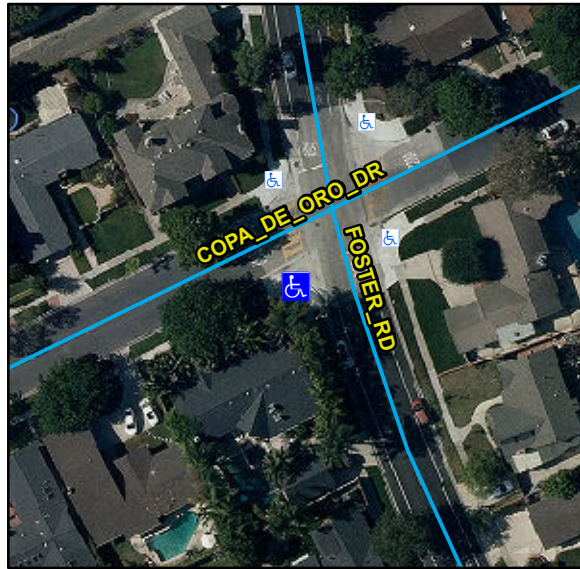
| Compliance | Description | Data | Compliance | Description | Data |
|---|---|---|---|---|---|
| No | Ramp Cross Slope LT (%) | 3.5 | No | Ramp Cross Slope RT (%) | 7.6 |

Remove & Replace Curb Ramp With Two New Directional Ramps or Equivalent.

R304.5.3, STD 1115
