# Access Compliance Report Public Rights-of-Way (Curb Ramps)

| Main Street: COPA_DE_ORO_DR | | Cross Street: FOSTER_RD | | Location: | NW |
| ADA ID: RPRK211207122728 | Ramp Type: Type 4 - Parallel | Initial Pass/Fail: Fail | Overall Compliance: No | Severity Score: | 15 |

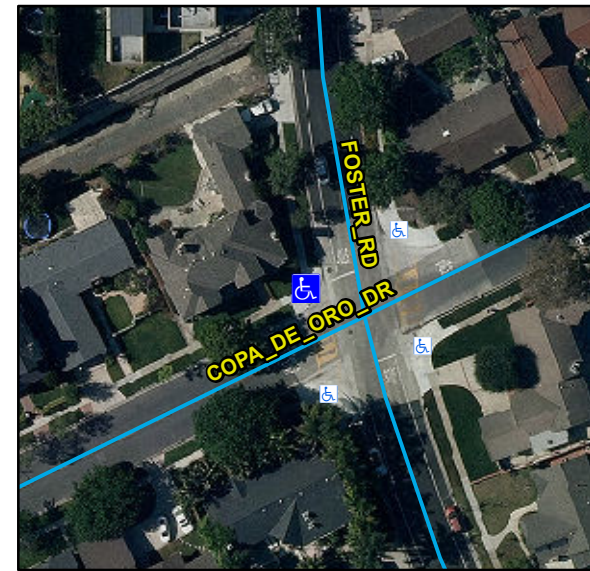
| Compliance | Description | Data | Compliance | Description | Data |
|---|---|---|---|---|---|
| Yes | Ramp Run Slope LT (%) | 2.6 | Yes | Ramp Run Slope RT (%) | 6.9 |
| No | Ramp Cross Slope LT (%) | 3.2 | No | Ramp Cross Slope RT (%) | 6.4 |

**Remove & Replace Curb Ramp With Two New Directional Ramps or Equivalent.**

**R304.5.3, STD 1115**

Total Cost: \$ 4000
