# Access Compliance Report Public Rights-of-Way (Curb Ramps)

Main Street: FOSTER\_RD Cross Street: COPA\_DE\_ORO\_DR Location: NE

ADA ID: RPRK211207123004 Ramp Type: Type 4 - Parallel Initial Pass/Fail: Fail Overall Compliance: No Severity Score: 15

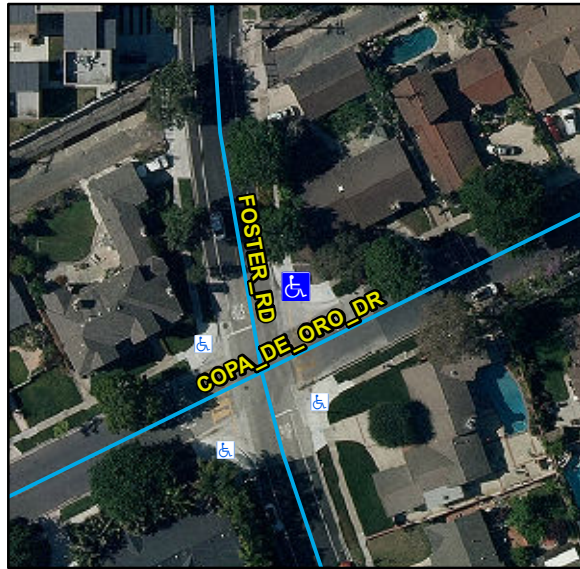
| Compliance | Description | Data | Compliance | Description | Data |
|---|---|---|---|---|---|
| No | Ramp Cross Slope LT (%) | 2.6 | No | Ramp Cross Slope RT (%) | 6.4 |

**Remove & Replace Curb Ramp With Two New Directional Ramps or Equivalent.**

**R304.5.3, STD 1115**
