# Access Compliance Report Public Rights-of-Way (Curb Ramps)

| Main Street: COPA_DE_ORO_DR | | Cross Street: FOSTER_RD | | Location: | SE |
| ADA ID: RPRK211207123319 | Ramp Type: Type 4 - Parallel | Initial Pass/Fail: Fail | Overall Compliance: No | Severity Score: | 30 |

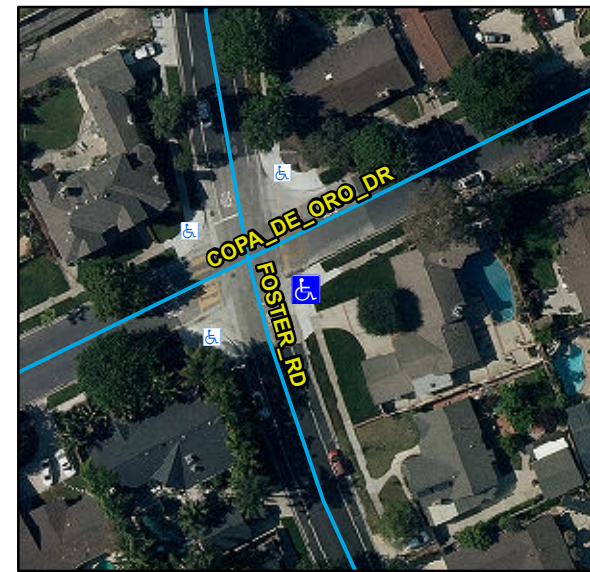
| Compliance | Description | Data | Compliance | Description | Data |
|---|---|---|---|---|---|
| No | Ramp Cross Slope LT (%) | 3.1 | No | Ramp Cross Slope RT (%) | 8.7 |

Possible Solutions:

**Remove & Replace Curb Ramp With Two New Directional Ramps or Equivalent.**

**R304.5.3, STD 1115**

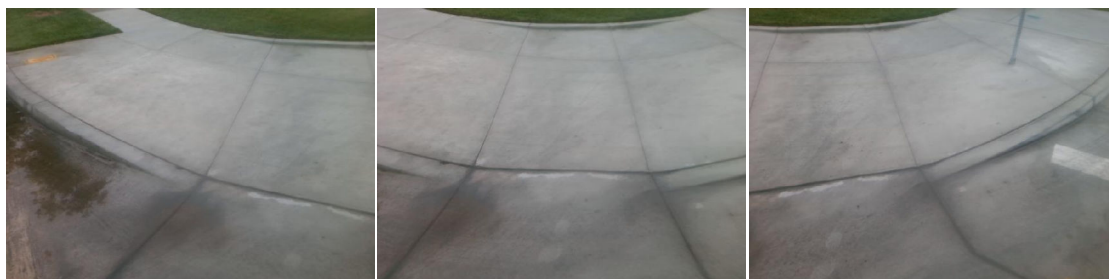
| Compliance | Description | Data | Compliance | Description | Data |
|---|---|---|---|---|---|
| N/A | Ramp Length LT (in) | 79 | N/A | Ramp Length RT (in) | 83 |
| Yes | Ramp Width LT (in) | 81 | Yes | Ramp Width RT (in) | 81 |
| Yes | Ramp Run Slope LT (%) | 2.9 | Yes | Ramp Run Slope RT (%) | 7 |
