# Access Compliance Report Public Rights-of-Way (Curb Ramps)

Main Street: WALKER\_LEE\_DR Cross Street: FOSTER\_RD Location: NW

ADA ID: RPRK211207123820 Ramp Type: Type 1 - Perpendicular Diagonal Initial Pass/Fail: Fail Overall Compliance: No Severity Score: 15

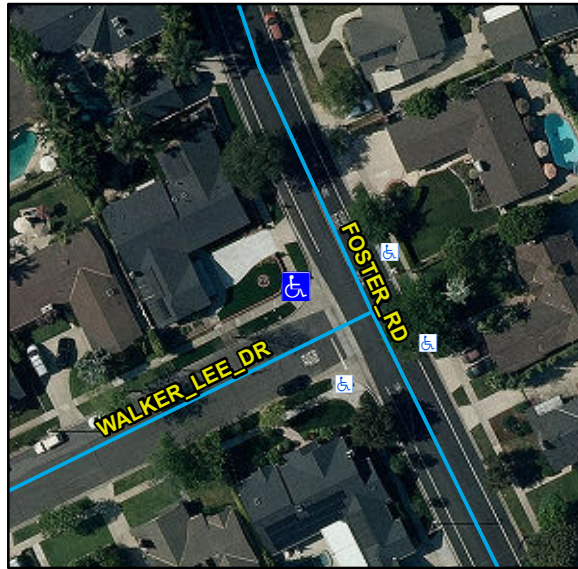
| Compliance | Description | Data | Compliance | Description | Data |
|---|---|---|---|---|---|
| No | Ramp Cross Slope (%) | 5.3 | N/A | Flare Traversable LT | N/A |

Remove & Replace Curb Ramp With Two New Directional Ramps or Equivalent.

R204.3, R304.5.3, STD 1115
