# Access Compliance Report Public Rights-of-Way (Curb Ramps)

Main Street: FOSTER\_RD Cross Street: WALKER\_LEE\_DR Location: SW

ADA ID: RPRK211207124027 Ramp Type: Type 1 - Perpendicular Diagonal Initial Pass/Fail: Fail Overall Compliance: No Severity Score: 2

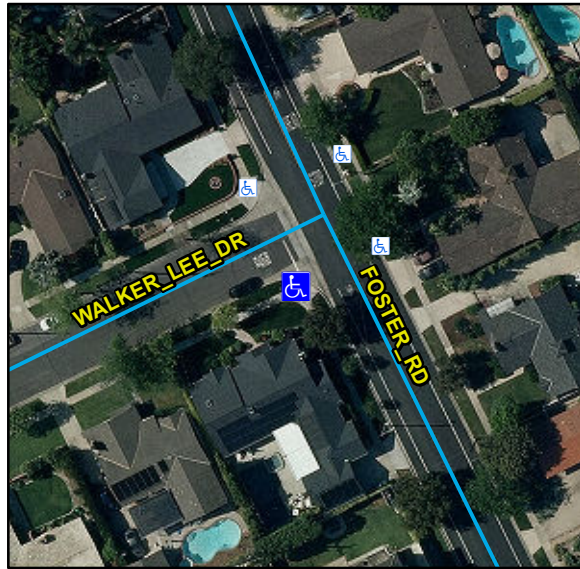
| Compliance | Description | Data | Compliance | Description | Data |
|---|---|---|---|---|---|
| No | Ramp Cross Slope (%) | 2.1 | N/A | Flare Traversable LT | N/A |

Remove & Replace Curb Ramp With Two New Directional Ramps or Equivalent.

R204.3, R304.5.3, STD 1115
