# Access Compliance Report Public Rights-of-Way (Curb Ramps)

Main Street: BRIMHALL\_DR Cross Street: FOSTER\_RD Location: NW

ADA ID: RPRK211207124355 Ramp Type: Type 1 - Perpendicular Diagonal Initial Pass/Fail: Fail Overall Compliance: No Severity Score: 2

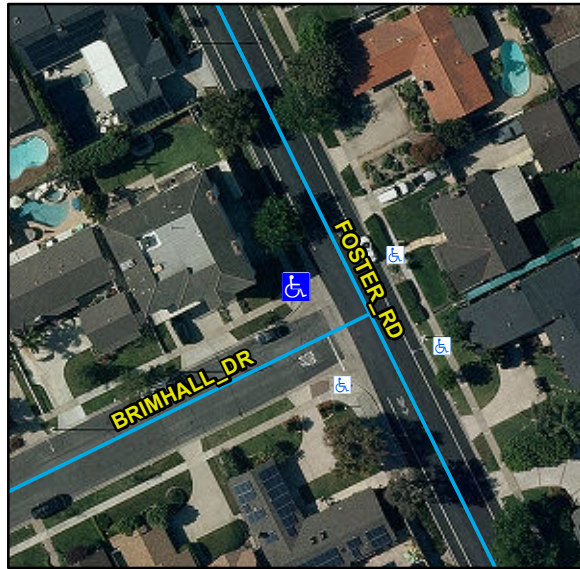
| Compliance | Description | Data | Compliance | Description | Data |
|---|---|---|---|---|---|
| No | Ramp Cross Slope (%) | 2.9 | N/A | Flare Traversable LT | N/A |

Remove & Replace Curb Ramp With Two New Directional Ramps or Equivalent.

R204.3, R304.5.3, STD 1115
