# Access Compliance Report Public Rights-of-Way (Curb Ramps)

Main Street: FOSTER\_RD Cross Street: BRIMHALL\_DR Location: SW

ADA ID: RPRK211207124525 Ramp Type: Type 1 - Perpendicular Diagonal Initial Pass/Fail: Pass Overall Compliance: No Severity Score: 10

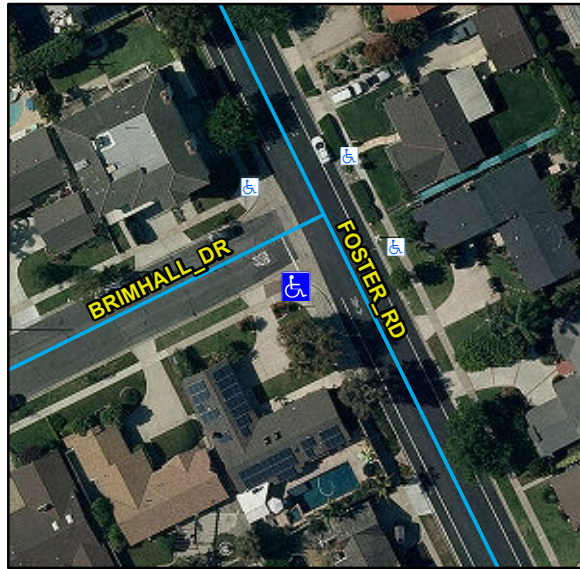
| Compliance | Description | Data | Compliance | Description | Data |
|---|---|---|---|---|---|
| No | Landing Cross Slope (%) | 2.2 | No | DWS Provided | No |
| No | Gutter Cross Slope (%) | 3 | | | |

Remove & Replace Curb Ramp With Two New Directional Ramps or Equivalent. Remove & Replace Gutter.

R204.3, R304.5.3, R305, STD 1115
