# Access Compliance Report Public Rights-of-Way (Curb Ramps)

Main Street: FOSTER\_RD Cross Street: TIGERTAIL\_DR Location: SW

ADA ID: RPRK211207125339 Ramp Type: Type 1 - Perpendicular Diagonal Initial Pass/Fail: Pass Overall Compliance: No Severity Score: 5

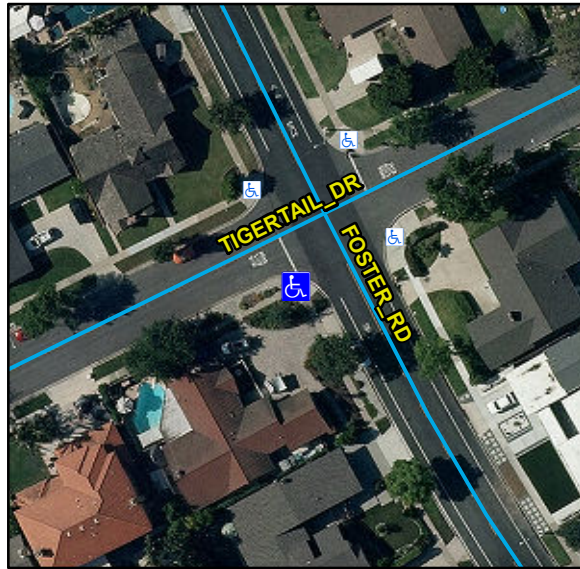
| Compliance | Description | Data | Compliance | Description | Data |
|---|---|---|---|---|---|
| Yes | Gutter Ponding | No | No | Curb Slope | 7.2 |
| No | Gutter Run Slope (%) | 5.6 | | Road Cross Slope (%) | 8.9 |
| No | Gutter Cross Slope (%) | 3.7 | | | |

Remove & Replace Curb Slope. Remove & Replace Gutter.
