# Access Compliance Report Public Rights-of-Way (Curb Ramps)

Main Street: TIGERTAIL\_DR Cross Street: FOSTER\_RD Location: SE

ADA ID: RPRK211207125708 Ramp Type: Type 1 - Perpendicular Diagonal Initial Pass/Fail: Fail Overall Compliance: No Severity Score: 2

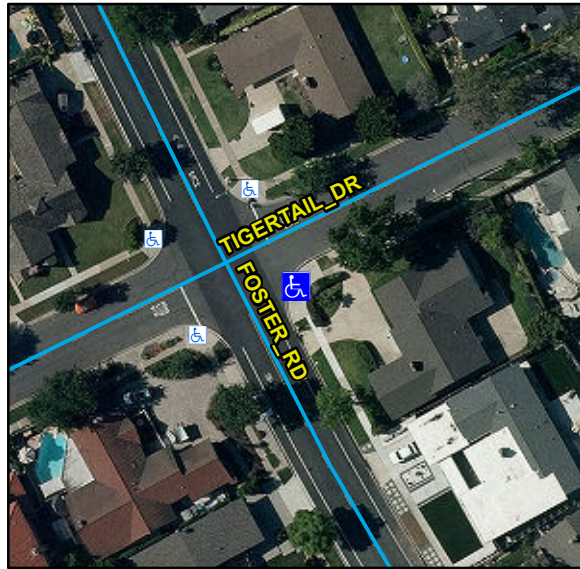
| Compliance | Description | Data | Compliance | Description | Data |
|---|---|---|---|---|---|
| No | Ramp Cross Slope (%) | 2.8 | N/A | Flare Traversable LT | N/A |

Remove & Replace Curb Ramp With Two New Directional Ramps or Equivalent.

R304.2.2, R204.3, R304.5.3, STD 1115
