# Access Compliance Report Public Rights-of-Way (Curb Ramps)

Main Street: FOSTER\_RD Cross Street: TIGERTAIL\_DR Location: NE

ADA ID: RPRK211207125926 Ramp Type: Type 1 - Perpendicular Diagonal Initial Pass/Fail: Pass Overall Compliance: No Severity Score: 0

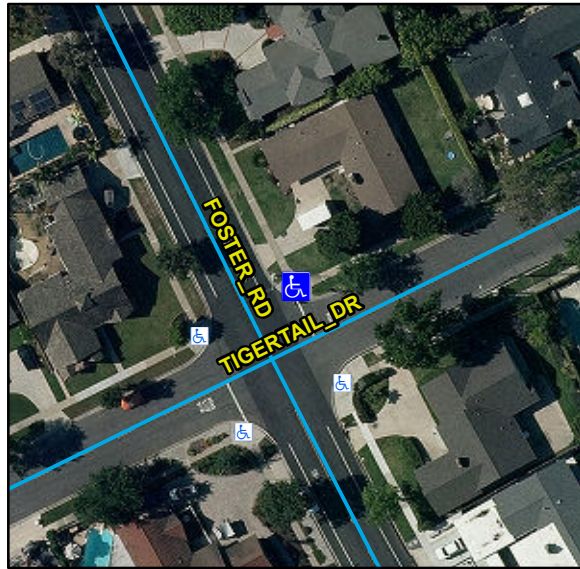
| Compliance | Description | Data | Compliance | Description | Data |
|---|---|---|---|---|---|
| No | Gutter Ponding | Yes | Yes | Curb Slope | 2.7 |
| No | Gutter Cross Slope (%) | 2.8 | | | |

Remove & Replace Gutter.

R302.7, R304.5.3, STD 1115
