# Access Compliance Report Public Rights-of-Way (Curb Ramps)

Main Street: TIGERTAIL\_DR Cross Street: CHRISTY\_LN Location: SE

ADA ID: RPRK211207130543 Ramp Type: Type 1 - Perpendicular Diagonal Initial Pass/Fail: Pass Overall Compliance: No Severity Score: 0

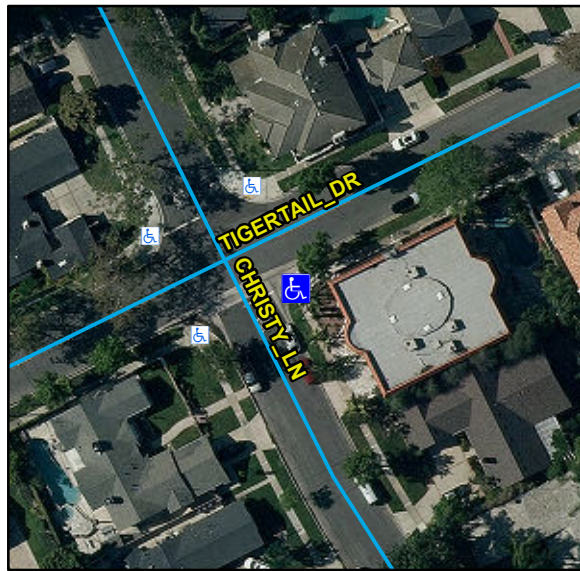
| Compliance | Description | Data | Compliance | Description | Data |
|---|---|---|---|---|---|
| No | Landing Cross Slope (%) | 2.3 | Yes | DWS Provided | Yes |

Remove & Replace Landing.

R304.2.1, R304.5.3, STD 1115
