# Access Compliance Report Public Rights-of-Way (Curb Ramps)

Main Street: CHRISTY\_LN Cross Street: TIGERTAIL\_DR Location: SW

ADA ID: RPRK211207130910 Ramp Type: Type 1 - Perpendicular Diagonal Initial Pass/Fail: Pass Overall Compliance: No Severity Score: 0

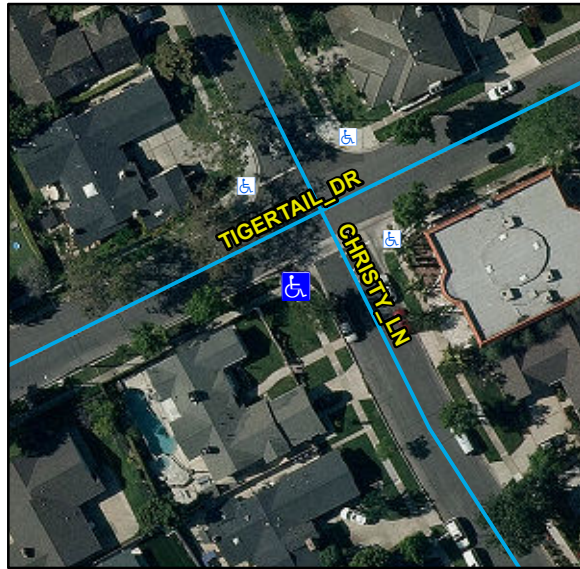
| Compliance | Description | Data | Compliance | Description | Data |
|---|---|---|---|---|---|
| No | Landing Cross Slope (%) | 2.1 | Yes | DWS Provided | Yes |

Remove & Replace Landing.

R304.5.3, STD 1115
