# Access Compliance Report Public Rights-of-Way (Curb Ramps)

| Main Street: TIGERTAIL_DR | | Cross Street: CHRISTY_LN | | Location: | NW |
| ADA ID: RPRK211207131215 | Ramp Type: Type 4 - Parallel | Initial Pass/Fail: Fail | Overall Compliance: No | Severity Score: | 30 |

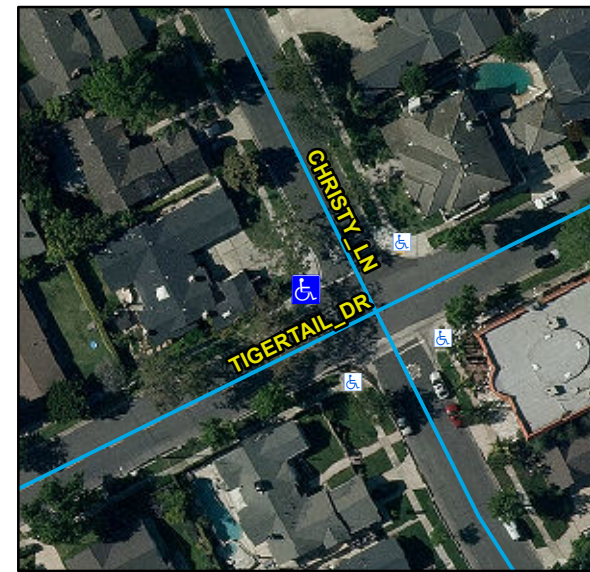
| Compliance | Description | Data | Compliance | Description | Data |
|---|---|---|---|---|---|
| No | Ramp Cross Slope LT (%) | 4.8 | No | Ramp Cross Slope RT (%) | 7.1 |

**Remove & Replace Curb Ramp With Two New Directional Ramps or Equivalent.**

**R304.5.3, STD 1115**

Total Cost: \$ 4000

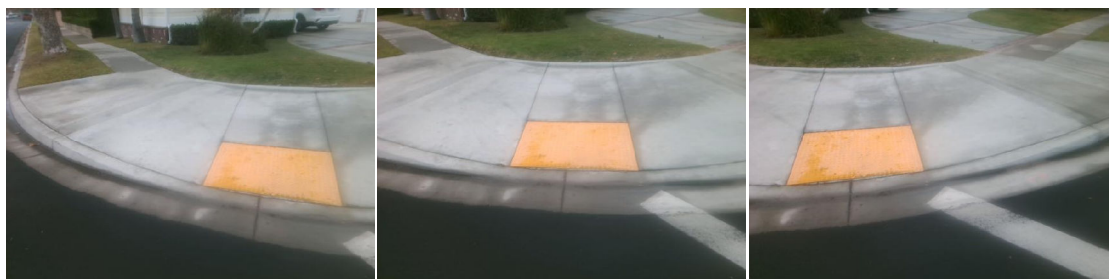
| Compliance | Description | Data | Compliance | Description | Data |
|---|---|---|---|---|---|
| N/A | Ramp Length LT (in) | 70 | N/A | Ramp Length RT (in) | 76 |
| Yes | Ramp Width LT (in) | 135 | Yes | Ramp Width RT (in) | 135 |
| Yes | Ramp Run Slope LT (%) | 5.2 | Yes | Ramp Run Slope RT (%) | 2 |
