# Access Compliance Report Public Rights-of-Way (Curb Ramps)

Main Street: CHRISTY\_LN Cross Street: TIGERTAIL\_DR Location: NE

ADA ID: RPRK211207131457 Ramp Type: Type 4 - Parallel Initial Pass/Fail: Fail Overall Compliance: No Severity Score: 30

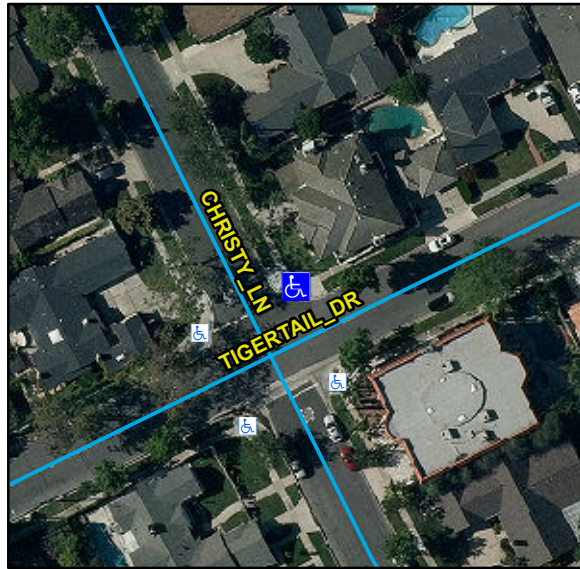
| Compliance | Description | Data | Compliance | Description | Data |
|---|---|---|---|---|---|
| No | Ramp Cross Slope LT (%) | 3.2 | No | Ramp Cross Slope RT (%) | 7.9 |

**Remove & Replace Curb Ramp With Two New Directional Ramps or Equivalent.**

**R304.5.3, STD 1115**
