# Access Compliance Report Public Rights-of-Way (Curb Ramps)

Main Street: BRIMHALL\_DR Cross Street: CHRISTY\_LN Location: SE

ADA ID: RPRK211207131843 Ramp Type: Type 1 - Perpendicular Diagonal Initial Pass/Fail: Fail Overall Compliance: No Severity Score: 2

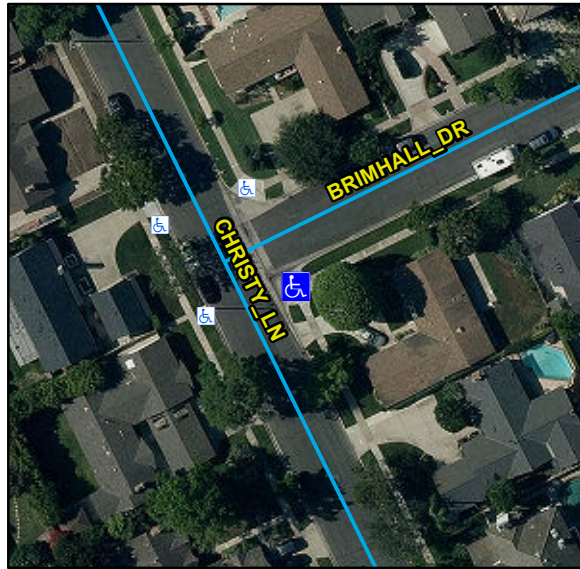
| Compliance | Description | Data | Compliance | Description | Data |
|---|---|---|---|---|---|
| No | Ramp Cross Slope (%) | 3.3 | N/A | Flare Traversable LT | N/A |

Remove & Replace Curb Ramp With Two New Directional Ramps or Equivalent.

R204.3, R304.5.3, STD 1115
