# Access Compliance Report Public Rights-of-Way (Curb Ramps)

Main Street: CHRISTY\_LN Cross Street: BRIMHALL\_DR Location: NE

ADA ID: RPRK211207132243 Ramp Type: Type 1 - Perpendicular Diagonal Initial Pass/Fail: Pass Overall Compliance: No Severity Score: 10

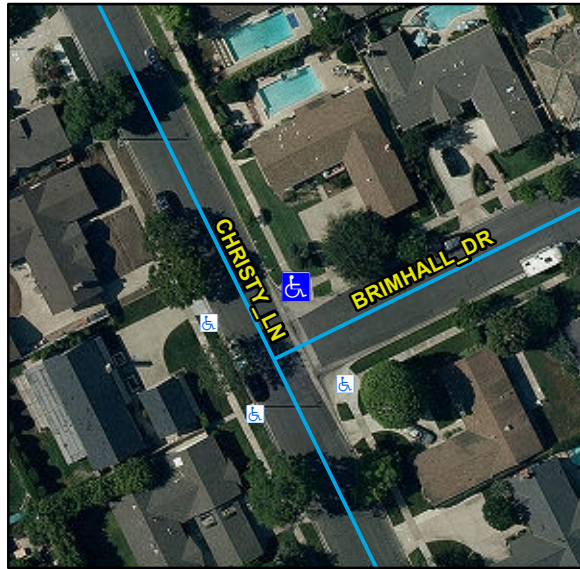
Remove & Replace Curb Ramp With Two New Directional Ramps or Equivalent. Gutter Ponding Observed.

| Compliance | Description | Data | Compliance | Description | Data |
|---|---|---|---|---|---|
| Yes | Landing Cross Slope (%) | 1.9 | No | DWS Provided | No |
| No | Gutter Ponding | Yes | Yes | Curb Slope | 4.8 |
