# Access Compliance Report Public Rights-of-Way (Curb Ramps)

Main Street: WALKER\_LEE\_DR Cross Street: CHRISTY\_LN Location: SE

ADA ID: RPRK211207132710 Ramp Type: Type 1 - Perpendicular Diagonal Initial Pass/Fail: Fail Overall Compliance: No Severity Score: 2

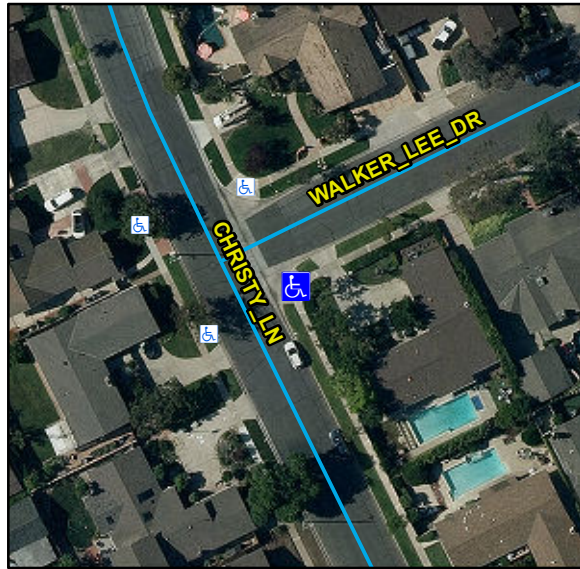
| Compliance | Description | Data | Compliance | Description | Data |
|---|---|---|---|---|---|
| No | Ramp Cross Slope (%) | 3.1 | N/A | Flare Traversable LT | N/A |

Remove & Replace Curb Ramp With Two New Directional Ramps or Equivalent.

R204.3, R304.5.3, STD 1115
